# Site 5

# Site 3

# Site 2

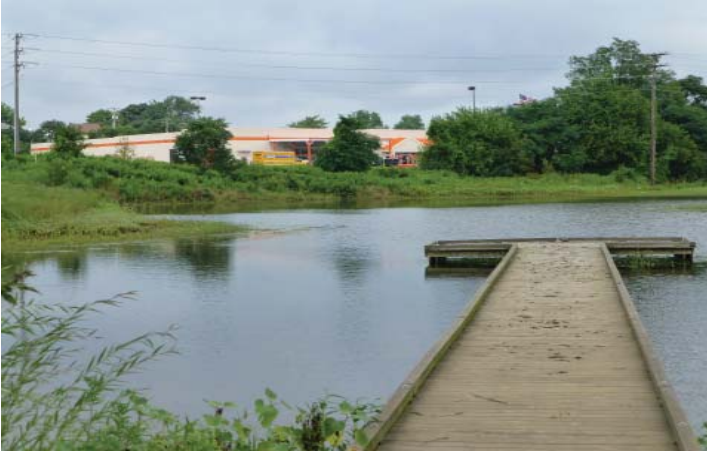
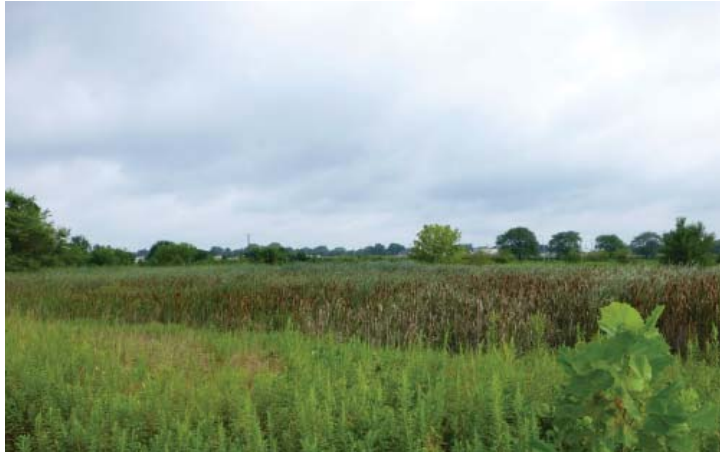
## EXISTING

**Description:** The site is currently developed as a large functioning wetland-wildlife area. There is a pond, boardwalks, educational signs and wetlands. The site is handling stormwater inflows from the Vo-Tech school as well as from a rock-lined channel inputting stormwater from the industrial area. The wetland vegetation is dominated by cattails and lacks diversity. There are few trees. The Quittapahilla enters the wetland site under Metro Drive, from the southeast.

**Potential:** Wetland enhancements would greatly benefit this existing BMP. The wetland is well positioned to handle stormwater and improve water quality of the Quittapahilla prior to it flowing through the lined channel through the City of Lebanon. Wetland enhancement could include invasive species management, planting of more trees and upper-canopy species, expansion of the wetland and stream incorporation. The wetland could be expanded to the east towards Metro Drive. Native no-mow areas or meadows could be implemented to replace the mowed lawn on the southwest corner of the site near the pavilion. The currently stone-lined channel could be converted to a bioswale to convey the stormwater from the industrial areas to the wetland. A restoration could better incorporate the Quittapahilla into the wetland, creating greater sinuosity of the channel, increasing the number of wetland pockets and improving the riparian buffer along the stream.

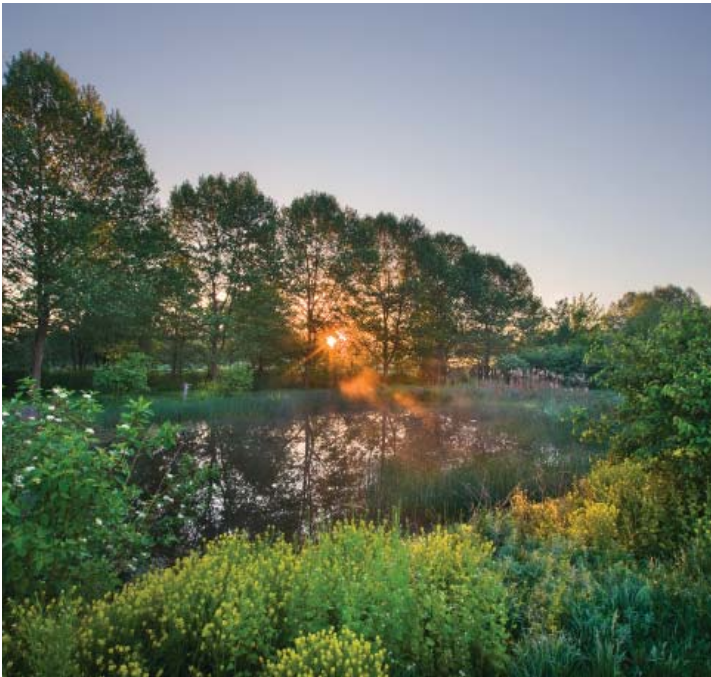
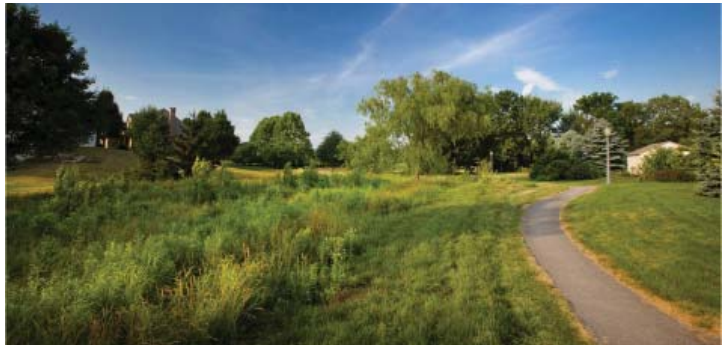
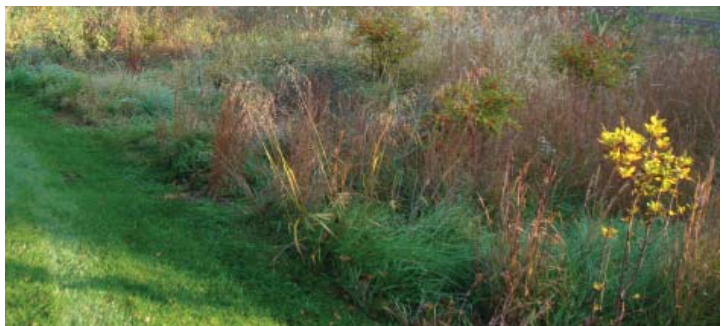
## PROPOSED

Lititz Run Riparian Park, Lititz PA

Top: Butterfly Acres, Lititz PA

Bottom: Susquehanna Bank Water Street, Lititz PA

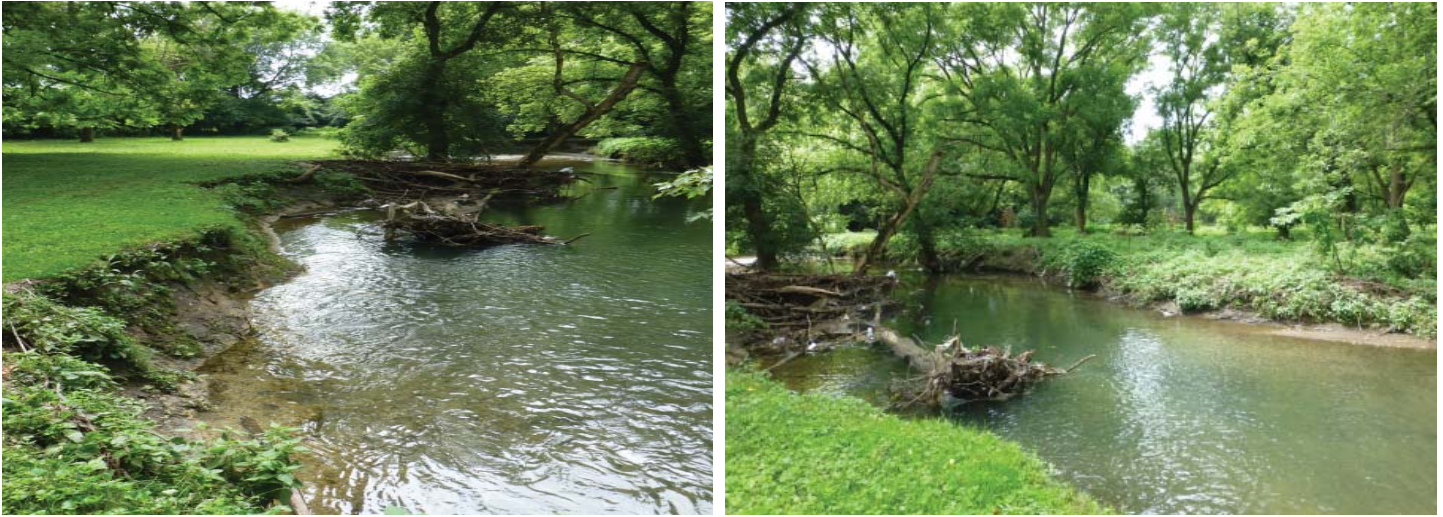
## EXISTING

**Description:** The site is currently mowed floodplain with scattered trees. There is not a significant mature canopy along most of the reach. It is adjacent to a sloping agricultural field under cultivation. The Quittapahilla Creek is unstable throughout the entire reach, with steep, raw eroding banks. The banks are undercut and contributing significant amounts of sediment to the stream. The Chestnut Street Bridge is closed, with visible storm damage to the concrete bridge. There is debris accumulating on the wire fence that has been put in place to close the road, evidence of storm events that cause the stream to flow overtop the bridge. The streambed substrate is sediment-laden and lacking aquatic habitat.

**Potential:** The site would be very well suited for a complete floodplain restoration. A restoration would remove significant amounts of sediment that is being contributed to the Quittapahilla. Improvements could include restoration of the banks to their historic elevation through removal of legacy sediment and implementation of riparian buffers, wetland pockets, & in-stream habitat structures. A restoration would increase the flood storage on-site as well as potentially provide regional storage. Unlike site 2, this site does not already have a mature riparian buffer and canopy, which would make it a more qualified candidate for a restoration. The site is in a prime location, directly downhill of an agricultural field. Improvements could help to filter nutrient runoff from the field before entering the Quittapahilla. The site has demonstrated its need for restoration, evident from the road closure and bridge failure due to flooding.

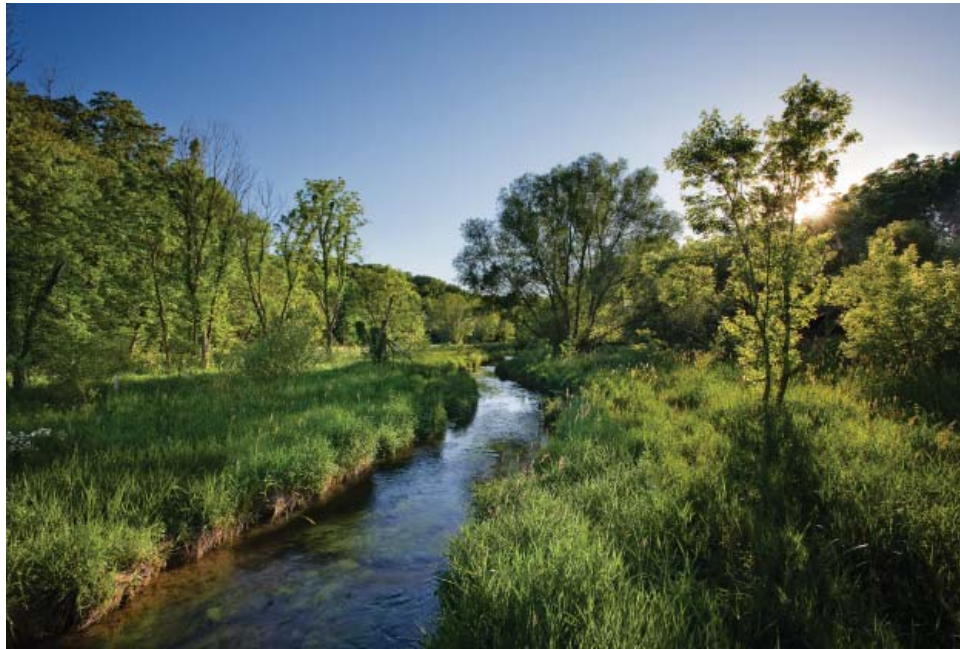
## PROPOSED

Lititz Run, Lititz PA

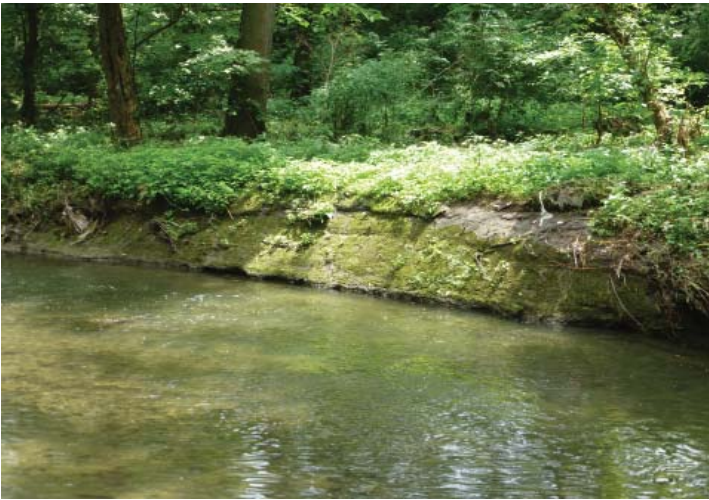
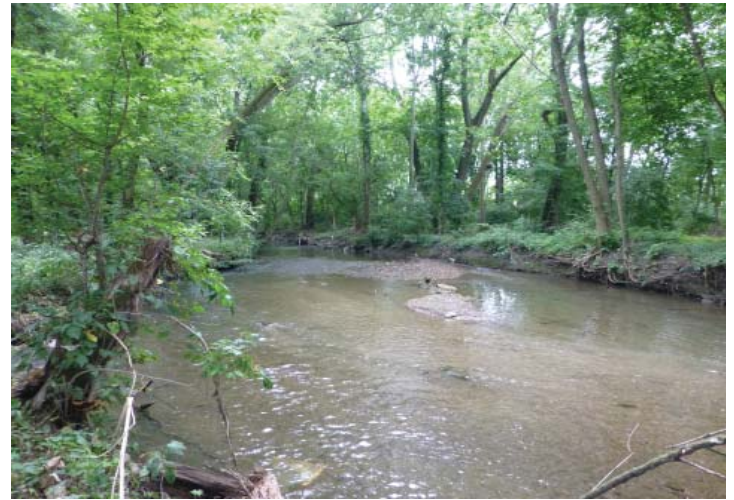
## EXISTING

**Description:** The Quittapahilla Creek is very unstable throughout this reach. The reach is approximately 1,700' in length, flowing with minor sinuosity through mature canopy. The banks are steeply eroded, undercut and unvegetated, approximately 5' in height in most places. The sediment-laden floodplain is highly disconnected and the stream over widened through the entire reach. There are a few large debris jams as well as large gravel bars. One outfall empties into the Quittapahilla from Chestnut Street, and an identified stream enters from the north. The floodplains on both sides of the stream show signs of recent flooding.

**Potential:** The site would be very well suited for a complete floodplain restoration. The site is receiving multiple stormwater inflows which could be better managed and treated. The site has potential for a future trail system along this reach. A restoration would remove significant amounts of sediment that is being contributed to the Quittapahilla. A restoration would increase the flood storage on-site as well as potentially provide regional storage. Improvements could include restoration of the banks to their historic elevation through removal of legacy sediment and implementation of riparian buffers, wetland pockets, & in-stream habitat structures. A potential downside is that a mature, dense canopy already exists along the Quittapahilla throughout this reach which would have to be removed through a complete restoration.

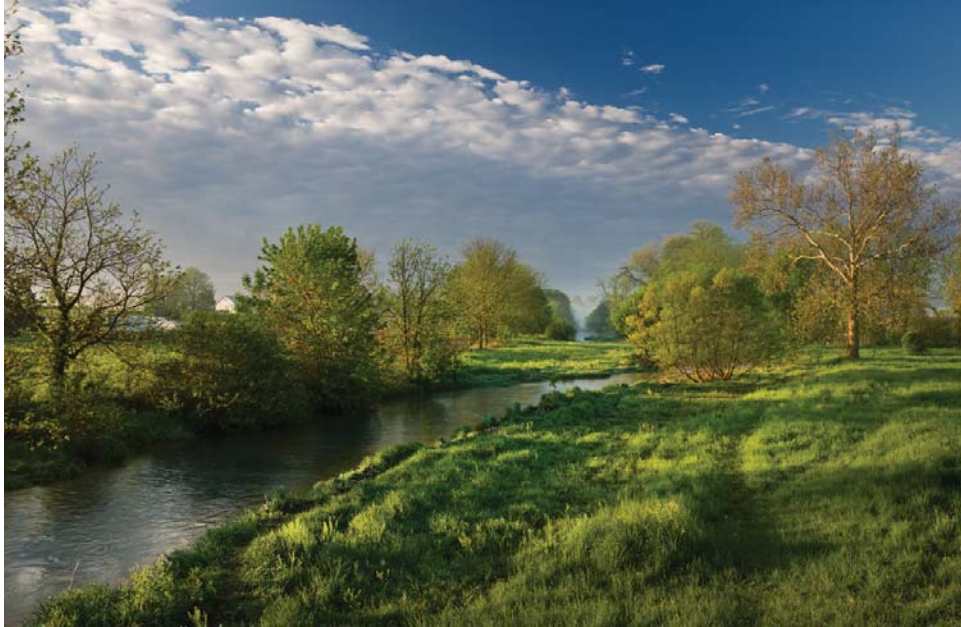
## PROPOSED

Lititz Run, Lititz PA
